April Tech Tip ... 3-Point Hitch Rate of Adjustment

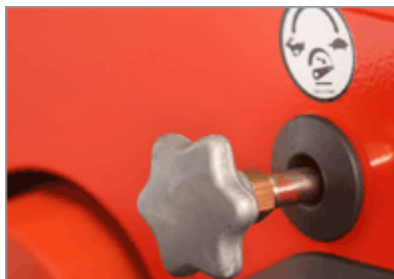
The picture below shows the Rate of Decent Valve adjustment knob for the Kioti CK27 compact tractor. Turning this knob *clockwise* will slow the rate of decent on your 3-point hitch... *counter-clockwise* will allow the 3-point hitch to drop faster.

Rate of Decent adjustment Knob

Remember... if you are unable to lower the 3-point hitch ... turn the adjustment knob *counter-clockwise*. If the 3-point hitch drops too fast ... turn the adjustment knob *clockwise*.
